**Tree Report**  
**Intersection Improvements**  
**El Camino Real at Ravenswood Avenue**

*Prepared for:*  
**City of Menlo Park**  
**Department of Public Works**  
**701 Laurel Street**  
**Menlo Park CA 94025**

*Prepared by:*  
**HortScience, Inc.**  
**325 Ray Street**  
**Pleasanton, CA 94566**

**July 2015**

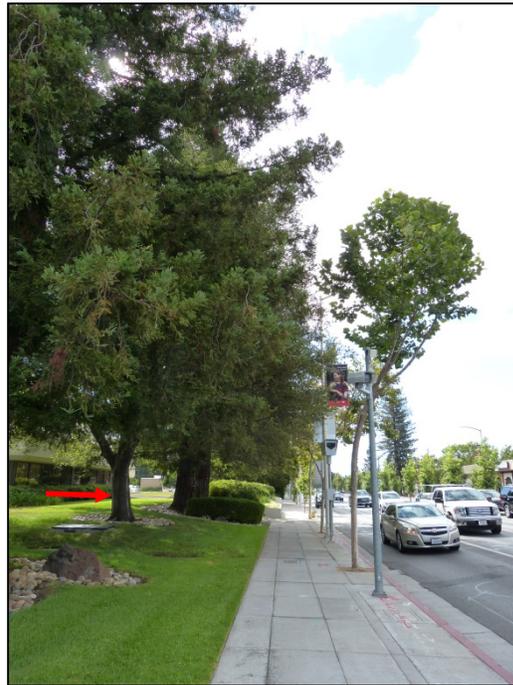
**Photo 1.** Looking south along El Camino Real near Ravenswood Avenue. Coast live oak #285 is in the left center (red arrow).

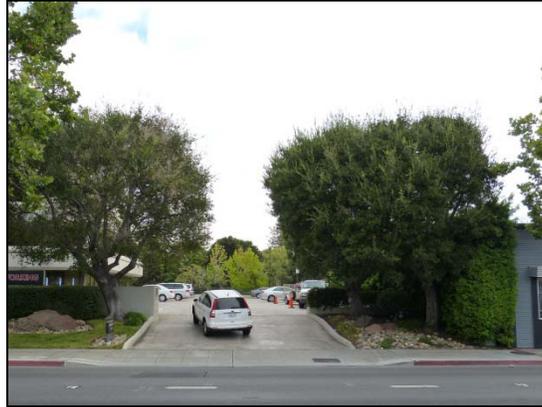
Coast live oaks #275, 276 and 277 were located at the south end of the Office Center (Photo 2). All three trees had been pruned many times to remove interior branches and foliage and reduce overall tree size. As a result, the trees had something of a sheared appearance.

**Photo 2.** Looking east across El Camino at coast live oaks #275 (right), 276 and 277 (left).

Trees #275 and 276 were adjacent to one another in a small planting area south of the driveway. Both were in good condition with dense canopies of foliage and the form and structure that is typical of the species. Tree #277 was on the north side of the driveway. The trunk was bowed, i.e., curved to the north but overall form was typical. The canopy was much thinner than that of #275 and 276. There was pronounced witch's broom development throughout the canopy. These distorted and discolored shoots reduced the overall appeal of the tree. These oaks ranged from 15' (#275) to 25' (276, 277) from the face of curb.

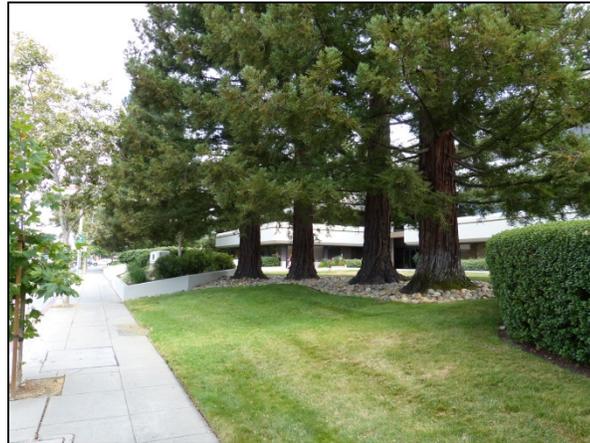
Coast redwoods #278 – 281 formed a row (Photo 3). This planting condition affected tree development. Trunk diameters ranged from 33" to 39". The two end trees, #278 and 281, were larger in diameter and in excellent condition. Both had somewhat one-sided crowns to the south or north as a result of competition with the interior trees. Trees #279 and 280 were in good condition. Their crowns were flattened to the east and west. Surface and large buttress roots were present. Trees were 28' to 32' from the face of curb.

**Photo 3.** Looking north along El Camino Real at coast redwoods #278 (right) to #281 (left).

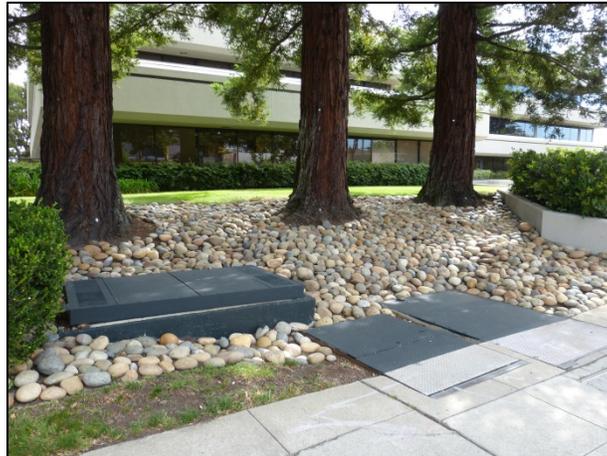
Coast redwoods #282 – 284 also formed a small group (Photo 4). The two end trees (#282, 284) were in excellent condition although somewhat one-sided in form. Trunk diameters were 37" and 36" respectively. The interior tree was 33" and in good condition with a form that was somewhat flat to the east and west. Surface and large buttress roots were present. Trees were 22' to 25' from the face of curb.

**Photo 4.** Coast redwoods #282 (right), 283 (center) and 284 (left). Note large utility vaults.

A number of utility vaults were located near the trees, between the trunks and the curb (Photo 4). For example, a telephone vault was 8' from the trunk of #283 while a PG&E vault was 4' from the trunk of #284.

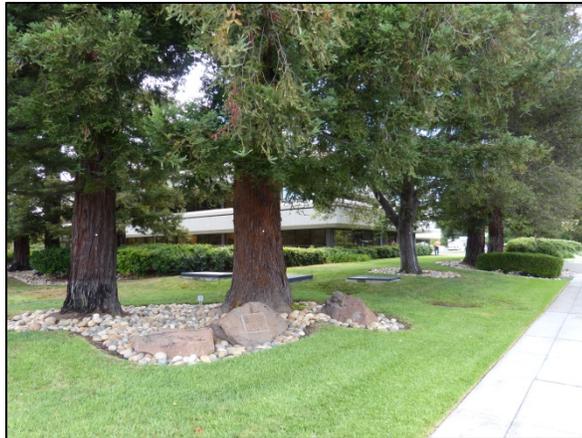
Coast redwoods #286 and 287 were at the north end of the landscape near Ravenswood Avenue (Photo 5). Trees were relatively close together. Both were in excellent condition. Tree #286 was 43" in diameter while #287 was 35". Redwood #286 was 24' from the face of curb; #287 was 33'.

**Photo 5.** Coast redwoods #286 (right) and 287 (left).

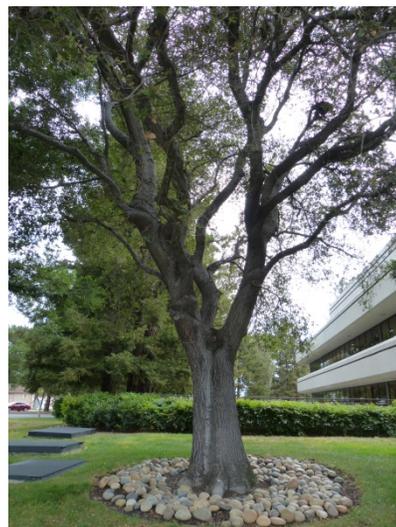
Coast live oak #285 was located between coast redwoods #284 and 286. It was 26" in diameter. The main trunk divided into 3 stems at 7'. The crown was somewhat vase-shaped as it had been lifted and tipped back by pruning. Overall development was also constrained by competition with the nearby redwoods. Tree condition was fair and the canopy was somewhat thin.

**Photo 6.** Looking east at coast live oak #285.
