Type of Services	Phase I Environmental Site Assessment
Location	10 Network Circle Menlo Park, California
Client	Roark Properties LLC
Client Address	1601 S. California Avenue Palo Alto, California 94304
Project Number	254-6-1
Date	November 3, 2010

Table of Contents

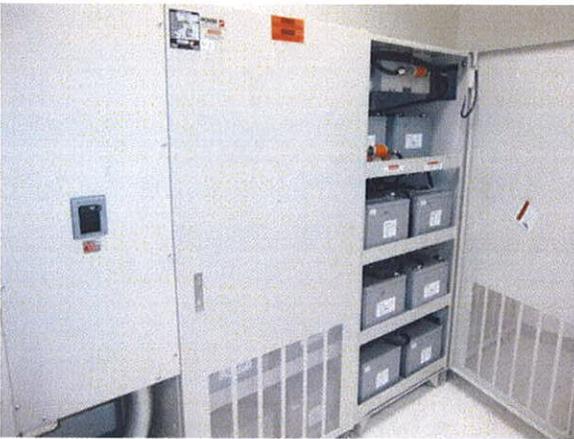
quart and 1-gallon capacities. Mr. Bartl indicated that the alcohols and soldering compounds are used in small quantities for occasional cleaning and soldering of electrical components within the hardware testing laboratories. Lead-acid batteries associated with uninterruptible power supply (UPS) systems also were observed in the laboratories. The batteries were located within secondarily contained cabinets. Laundry detergents used for washing towels were observed in a laundry room in Building 19 (the fitness center); several 5-gallon plastic containers were present. No evidence of hazardous materials spills or leaks within the buildings was readily apparent.

Photograph 9. Batteries in UPS cabinet

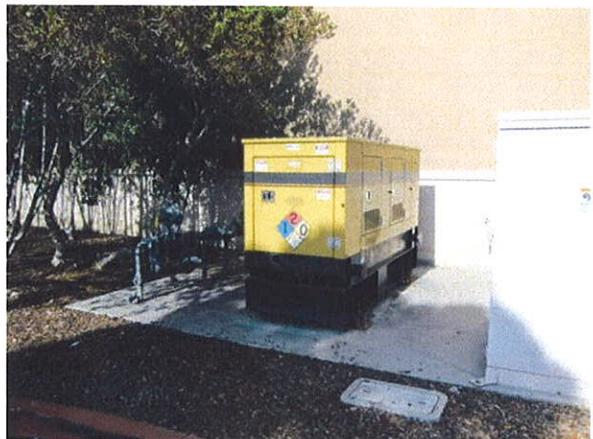
Nine emergency generators were observed on-Site, each with an integral, double-walled, above ground diesel storage tank. The generators were observed to be located on concrete pads or pavement. No evidence of diesel fuel leaks was readily apparent. Mr. Bartl indicated that seven of the generators provided emergency power for life safety systems, while the remaining two provide emergency power to computer laboratories.

Photograph 10. Emergency generator (1 of 9)

Facilities containing hazardous materials should be periodically inspected for leaks or other damage as part of normal Site maintenance activities. Appropriate procedures and control measures should be taken by vendors that service the elevators and transformers to minimize incidental spills or releases of oil. Spill equipment should be kept readily available near the emergency generators to absorb or contain releases, if any.

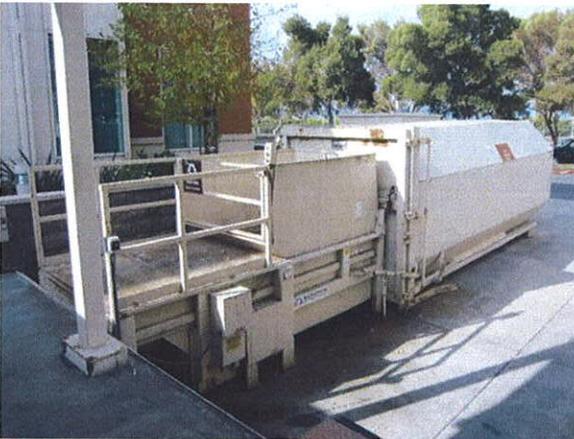
A loading dock was observed on the southeast side of Building 11. Smaller loading docks were observed between Buildings 10 and 12, between Buildings 14 and 16, and between Buildings 17 and 18. A hydraulic powered trash compactor was observed on concrete pavements at each of the loading docks. The hydraulic fluid reservoirs for the trash compactors appeared to be single-walled integral tanks with capacities of between 25 and 50 gallons. No evidence of hydraulic fluid leaks was readily apparent.

Photograph 11. Trash compactor.

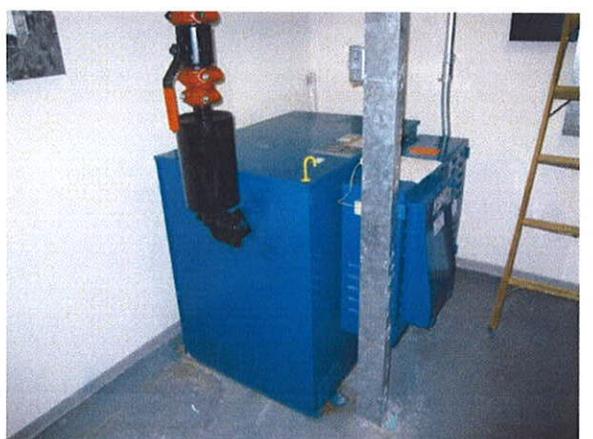
Two to three elevators were observed in each of the on-Site buildings, except for Building 19, and consisted of both passenger and freight elevators. Representative elevator equipment rooms were observed to contain hydraulic and mechanical equipment for the elevators. The observed equipment appeared to be in good conditions and no evidence of hydraulic fluid leaks was readily apparent. Mr. Andico indicated that the elevators are serviced by an outside vendor on a regular basis and that he was not aware of any prior issues that would be indicative of hydraulic fluid leaks.

Photograph 12. Elevator hydraulic equipment

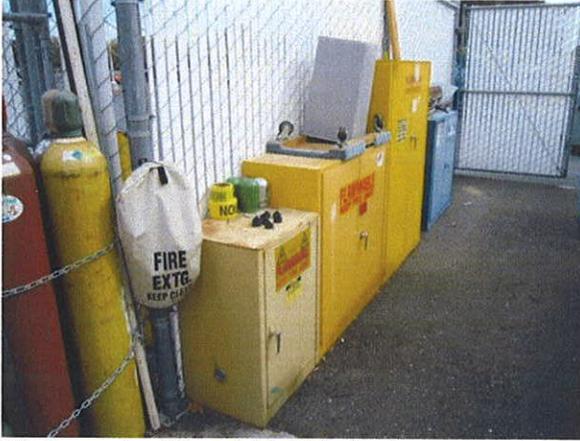
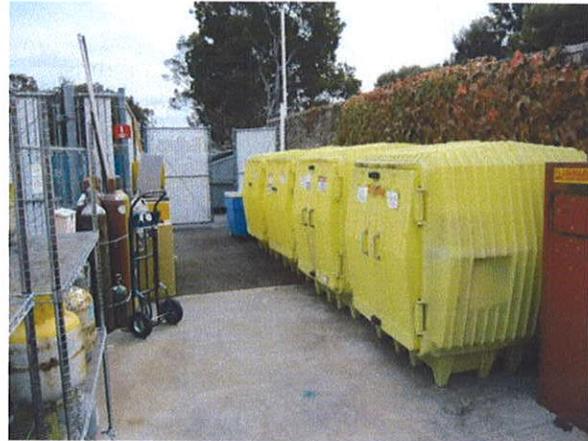
Typical janitorial cleaning supplies were observed in janitorial closets within the buildings. Additionally, isopropyl alcohol, water soluble and VOC-free soldering flux, and static control mat cleaner were observed in a hazardous materials storage cabinet in one of the hardware laboratories. These materials were observed to be stored in retail plastic containers with 1-

Photographs 13 and 14. Exterior hazardous materials storage area (southeast side of Building 11)

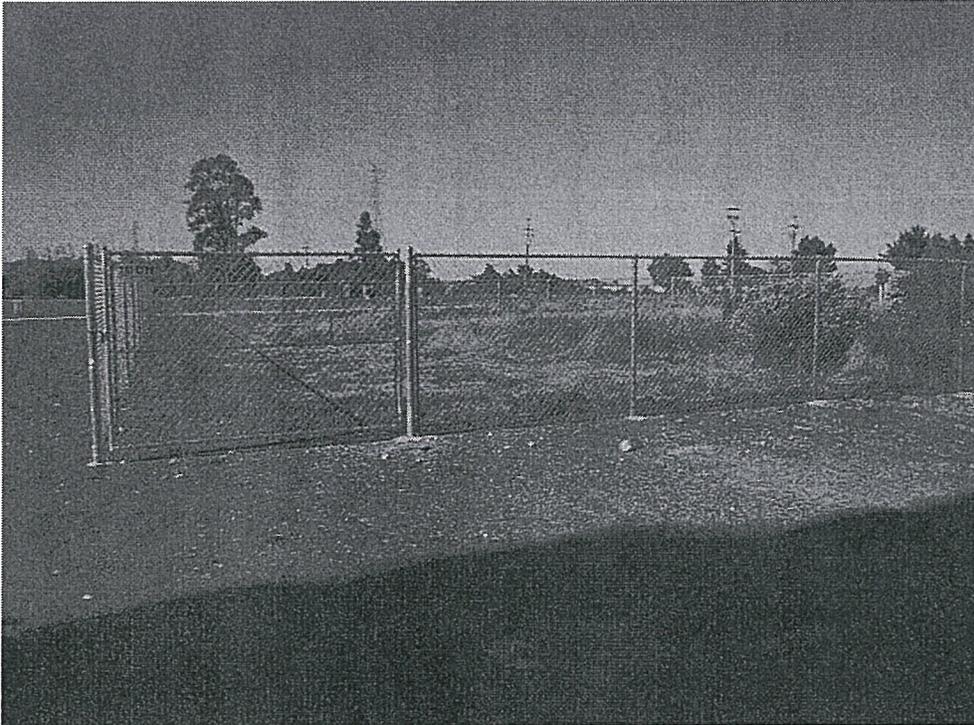
Photograph 12. Area of Capped PCB Impacted Soil on Eastern Parcel

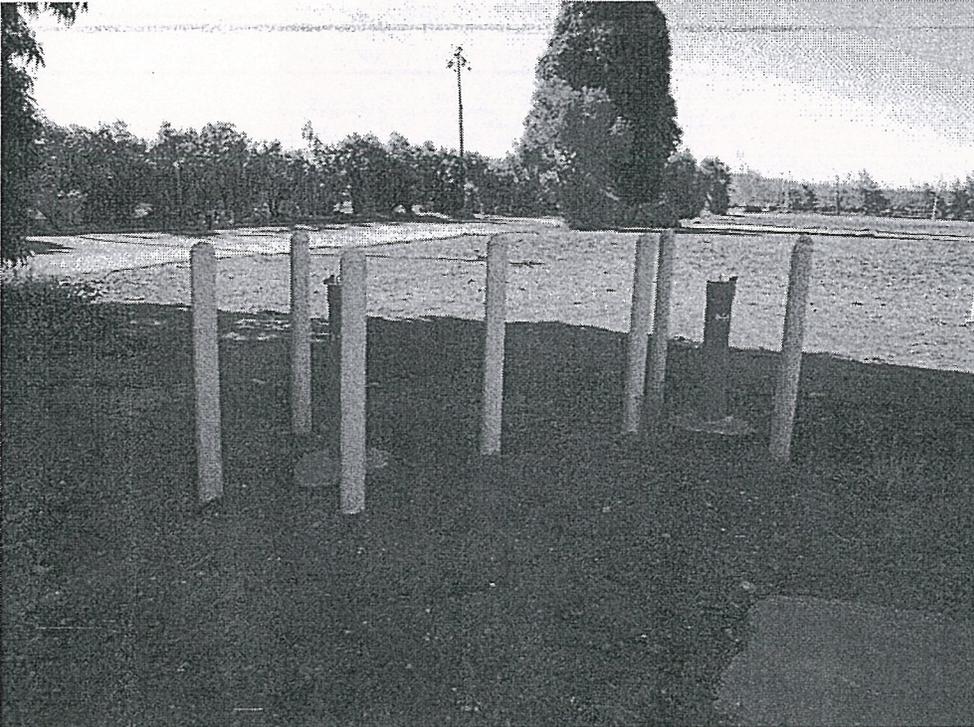
Photograph 13. Monitoring Wells on Eastern Parcel

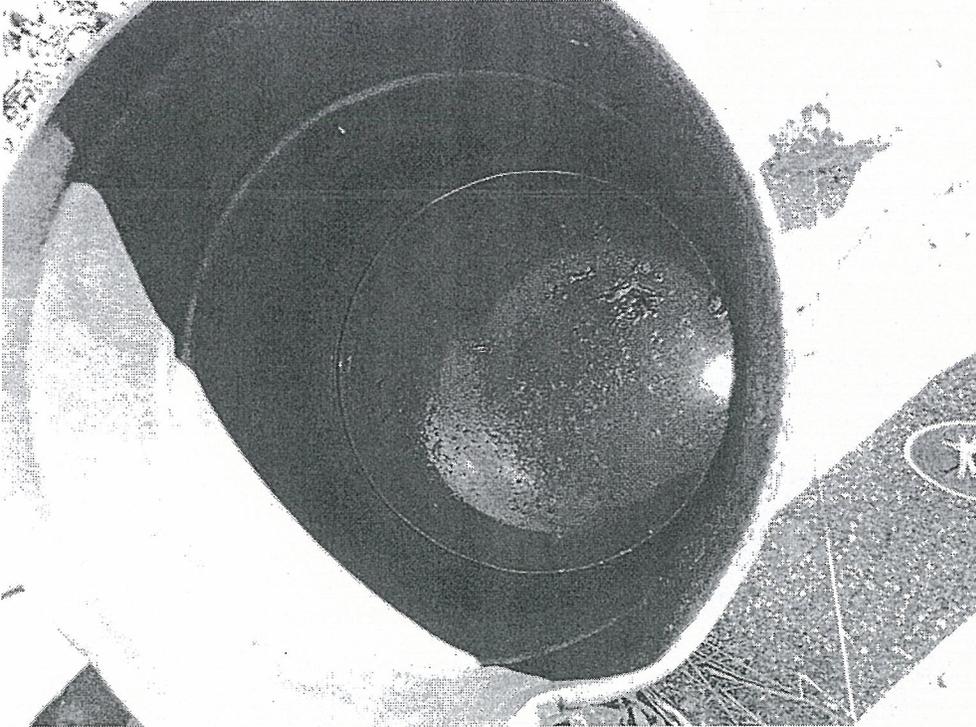
Photograph 16. 55-Gallon Drum with Oily Fluid on Eastern Parcel
