**Subject: Consider a Recommendation to the Planning Commission and City Council on a Request to Remove 22 Heritage Trees and Retain one Heritage Tree on property located at 151 Commonwealth Drive and 164 Jefferson Drive.**

A Planning Department Submittal for  
**COMMONWEALTH CORPORATE CENTER**  
 151 Commonwealth Drive and 164 Jefferson Drive  
 Menlo Park, California 94025

# ARBORIST SURVEY

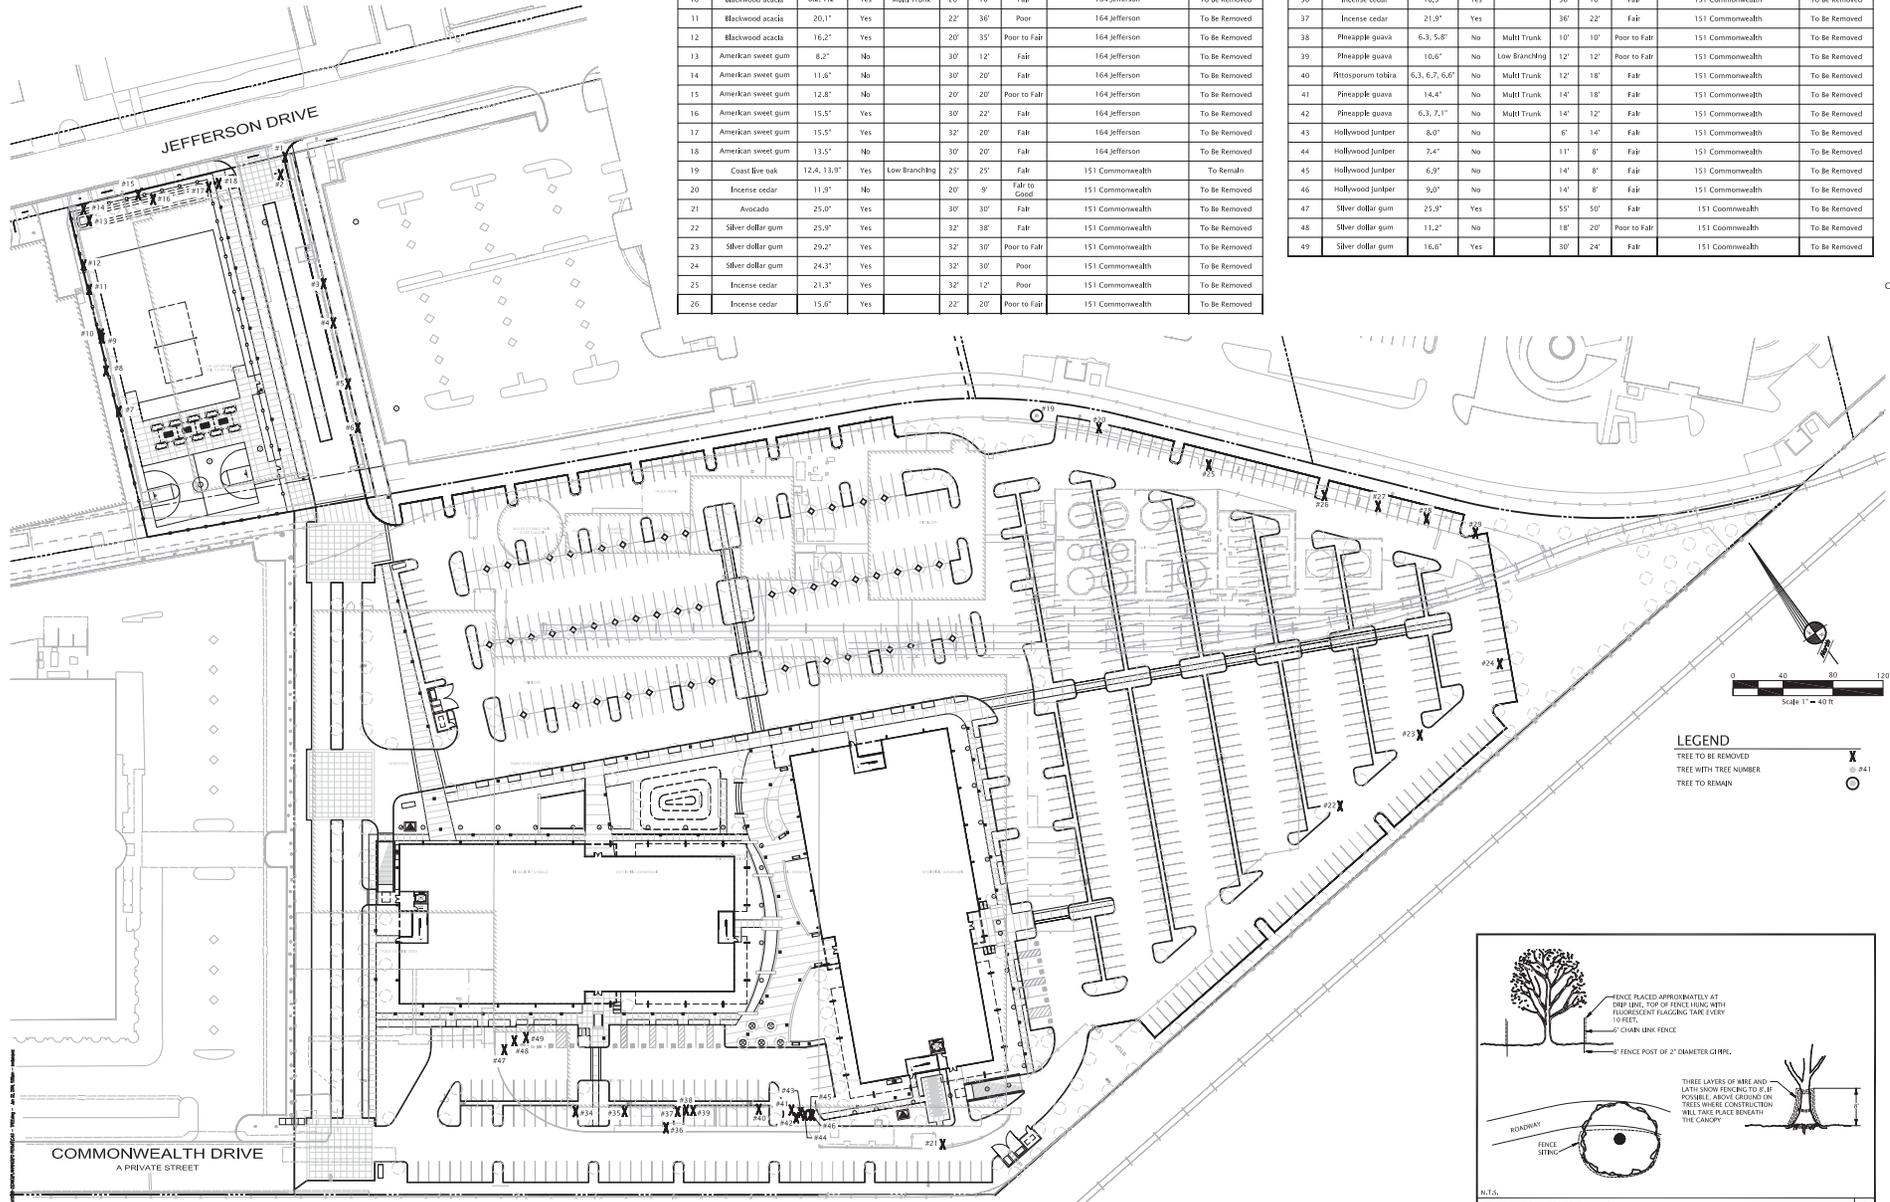
**TREE SURVEY & DISPOSITION PLAN**

**LEGEND**  
 TREE TO BE REMOVED: X  
 TREE WITH TREE NUMBER: O  
 TREE TO REMAIN: O

- (1) Require the retention of the Coast Live Oak (also identified as Tree 19); and,
- (2) Approve the removal of the other 22 heritage trees located on the site.
