BANK STABILIZATION AND REVEGETATION RECOMMENDATIONS

SAN FRANCISQUITO CREEK
BANK STABILIZATION & REVEGETATION
PRELIMINARY MASTER PLAN REPORT

Station: 303+00 to 326+00 September, 2000

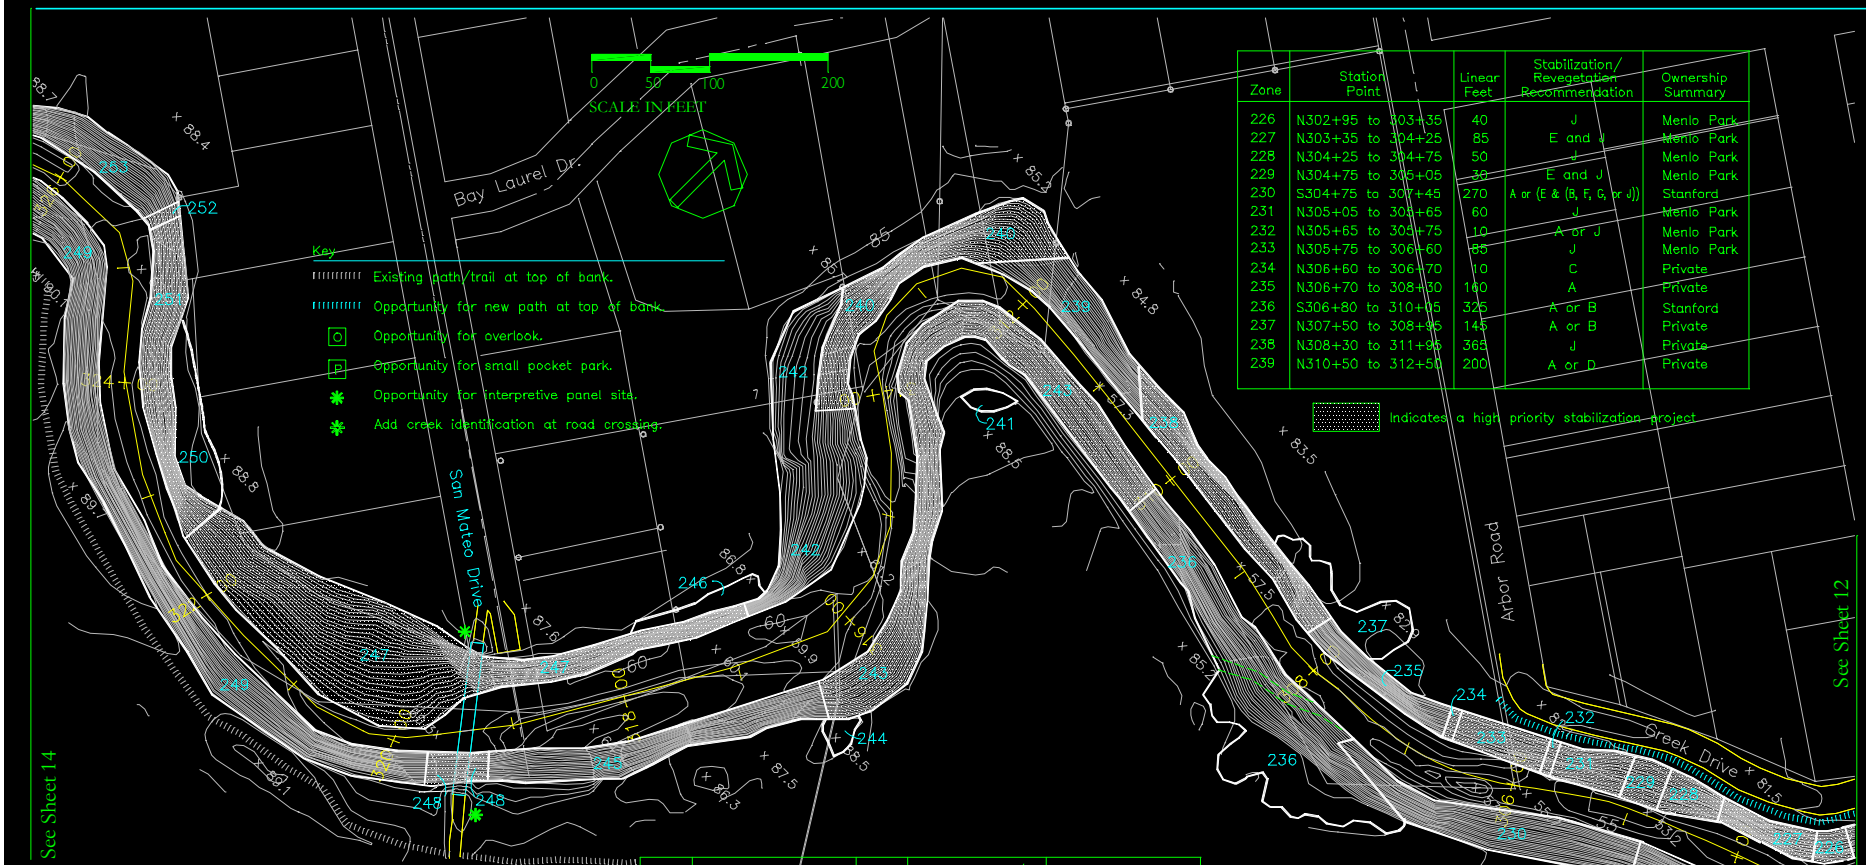
13

Zone	Station Point	Linear Feet	Stabilization/ Revegetation Recommendation	Ownership Summary
226	N302+95 to 303+35	40	J	Menlo Park
227	N303+35 to 304+25	85	E and J	Menlo Park
228	N304+25 to 304+75	50	J	Menlo Park
229	N304+75 to 305+05	30	E and J	Menlo Park
230	S304+75 to 307+45	270	A or (E & (B, F, G, or J))	Stanford
231	N305+05 to 305+65	60	J	Menlo Park
232	N305+65 to 305+75	10	A or J	Menlo Park
233	N305+75 to 306+60	85	J	Menlo Park
234	N306+60 to 306+70	10	C	Private
235	N306+70 to 308+30	160	A	Private
236	S306+80 to 310+05	325	A or B	Stanford
237	N307+50 to 308+95	145	A or B	Private
238	N308+30 to 311+95	365	J	Private
239	N310+50 to 312+50	200	A or D	Private

Indicates a high priority stabilization project

Zone	Station Point	Linear Feet	Stabilization/ Revegetation Recommendation	Ownership Summary
240	N311+80 to 314+15	235	J	Private
241	S311+25 to 311+85	60	A or B	Stanford
242	N313+40 to 316+70	330	A	Private
243	S310+05 to 316+40	635	F, G, I or J	Stanford
244	S316+10 to 316+40	30	A or B	Stanford
245	S316+40 to 319+20	280	A, B, F, G, I, or J	Stanford
246	N316+40 to 317+65	125	A or B	Private
247	N316+70 to 322+50	580	J	Private/Menlo Park
248	S319+20 to 319+70	50	I or J	Stanford
249	S319+70 to 335+15	15450	A, B, F, G, I, or J	Stanford
250	N322+50 to 324+50	200	A or B	Private
251	N322+50 to 326+30	380	E and J	Private
252	N326+30 to 326+45	15	C	Private
253	N326+45 to 327+95	150	A	Private
