BANK STABILIZATION AND REVEGETATION RECOMMENDATIONS

SAN FRANCISCO CREEK
BANK STABILIZATION & REVEGETATION
PRELIMINARY MASTER PLAN REPORT

Station: 326+00 to 339+00 September, 2000

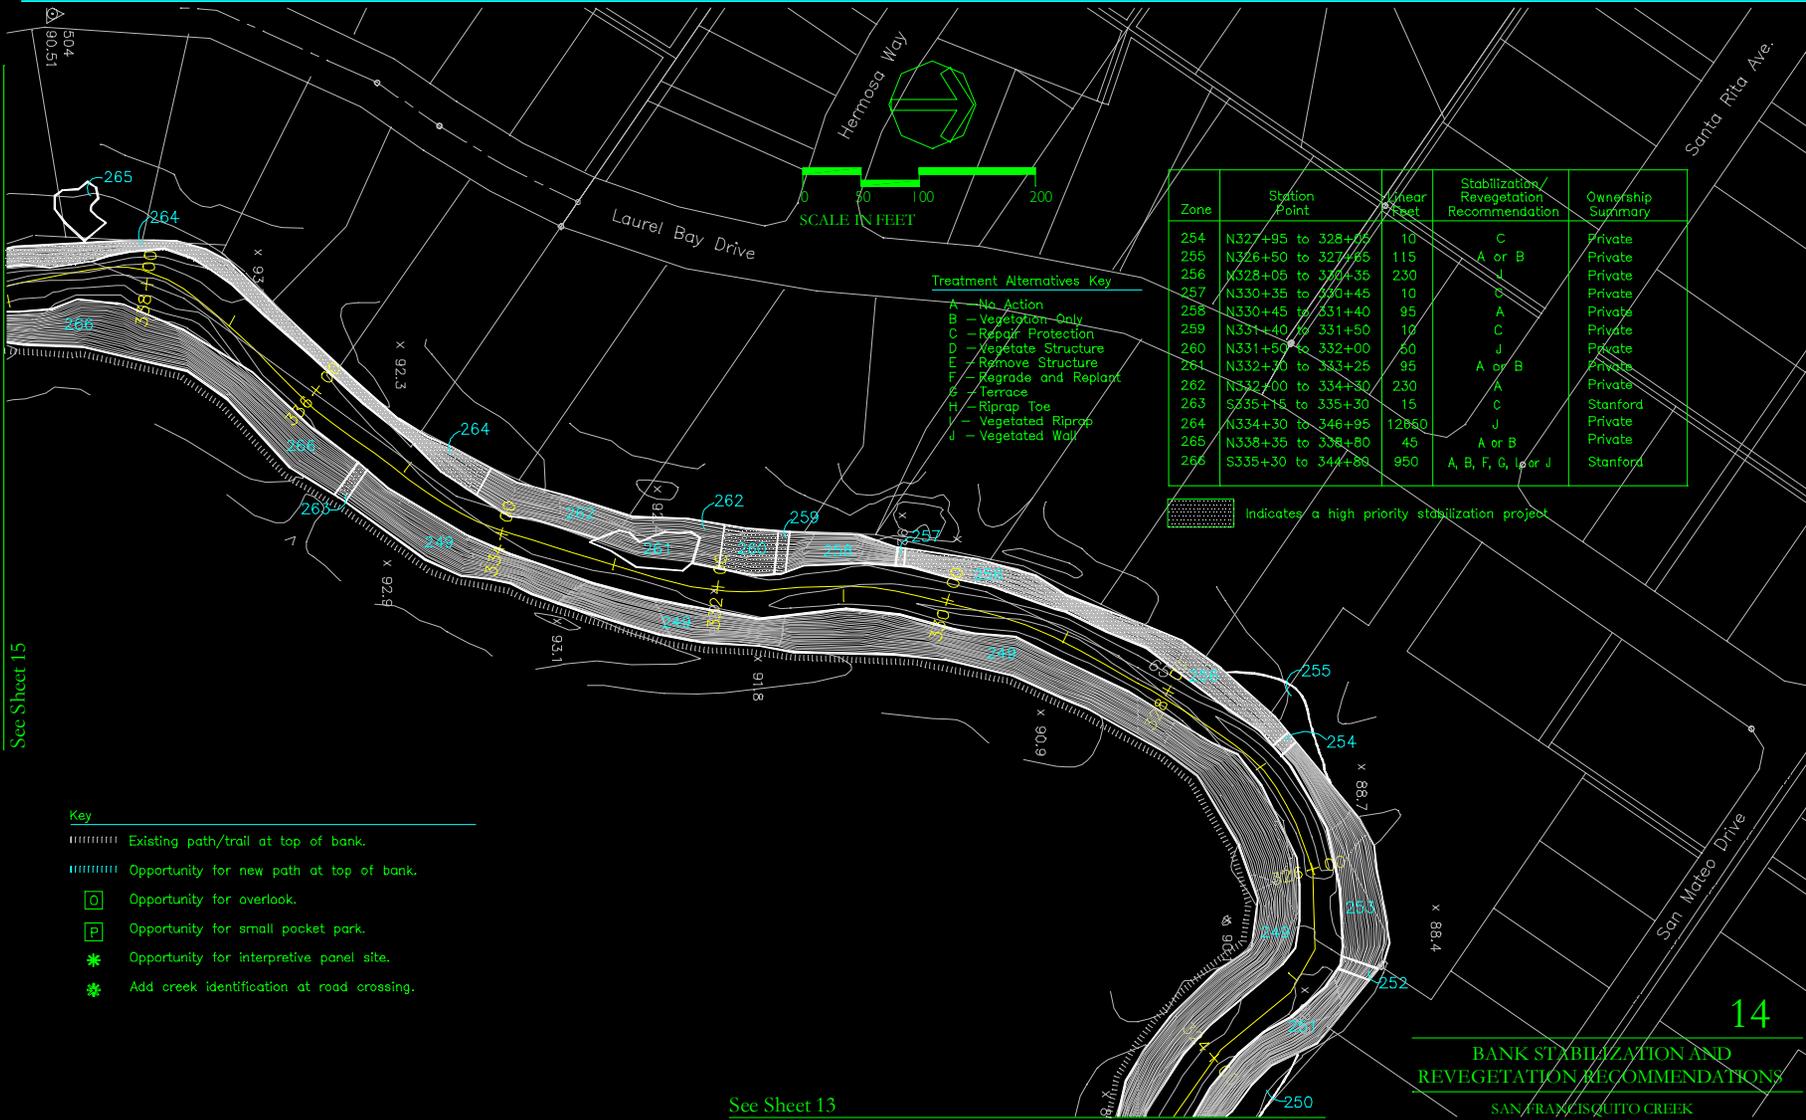
14

Indicates a high priority stabilization project
