BANK STABILIZATION AND REVEGETATION RECOMMENDATIONS
 SAN FRANCISQUITO CREEK
 BANK STABILIZATION & REVEGETATION
 PRELIMINARY MASTER PLAN REPORT

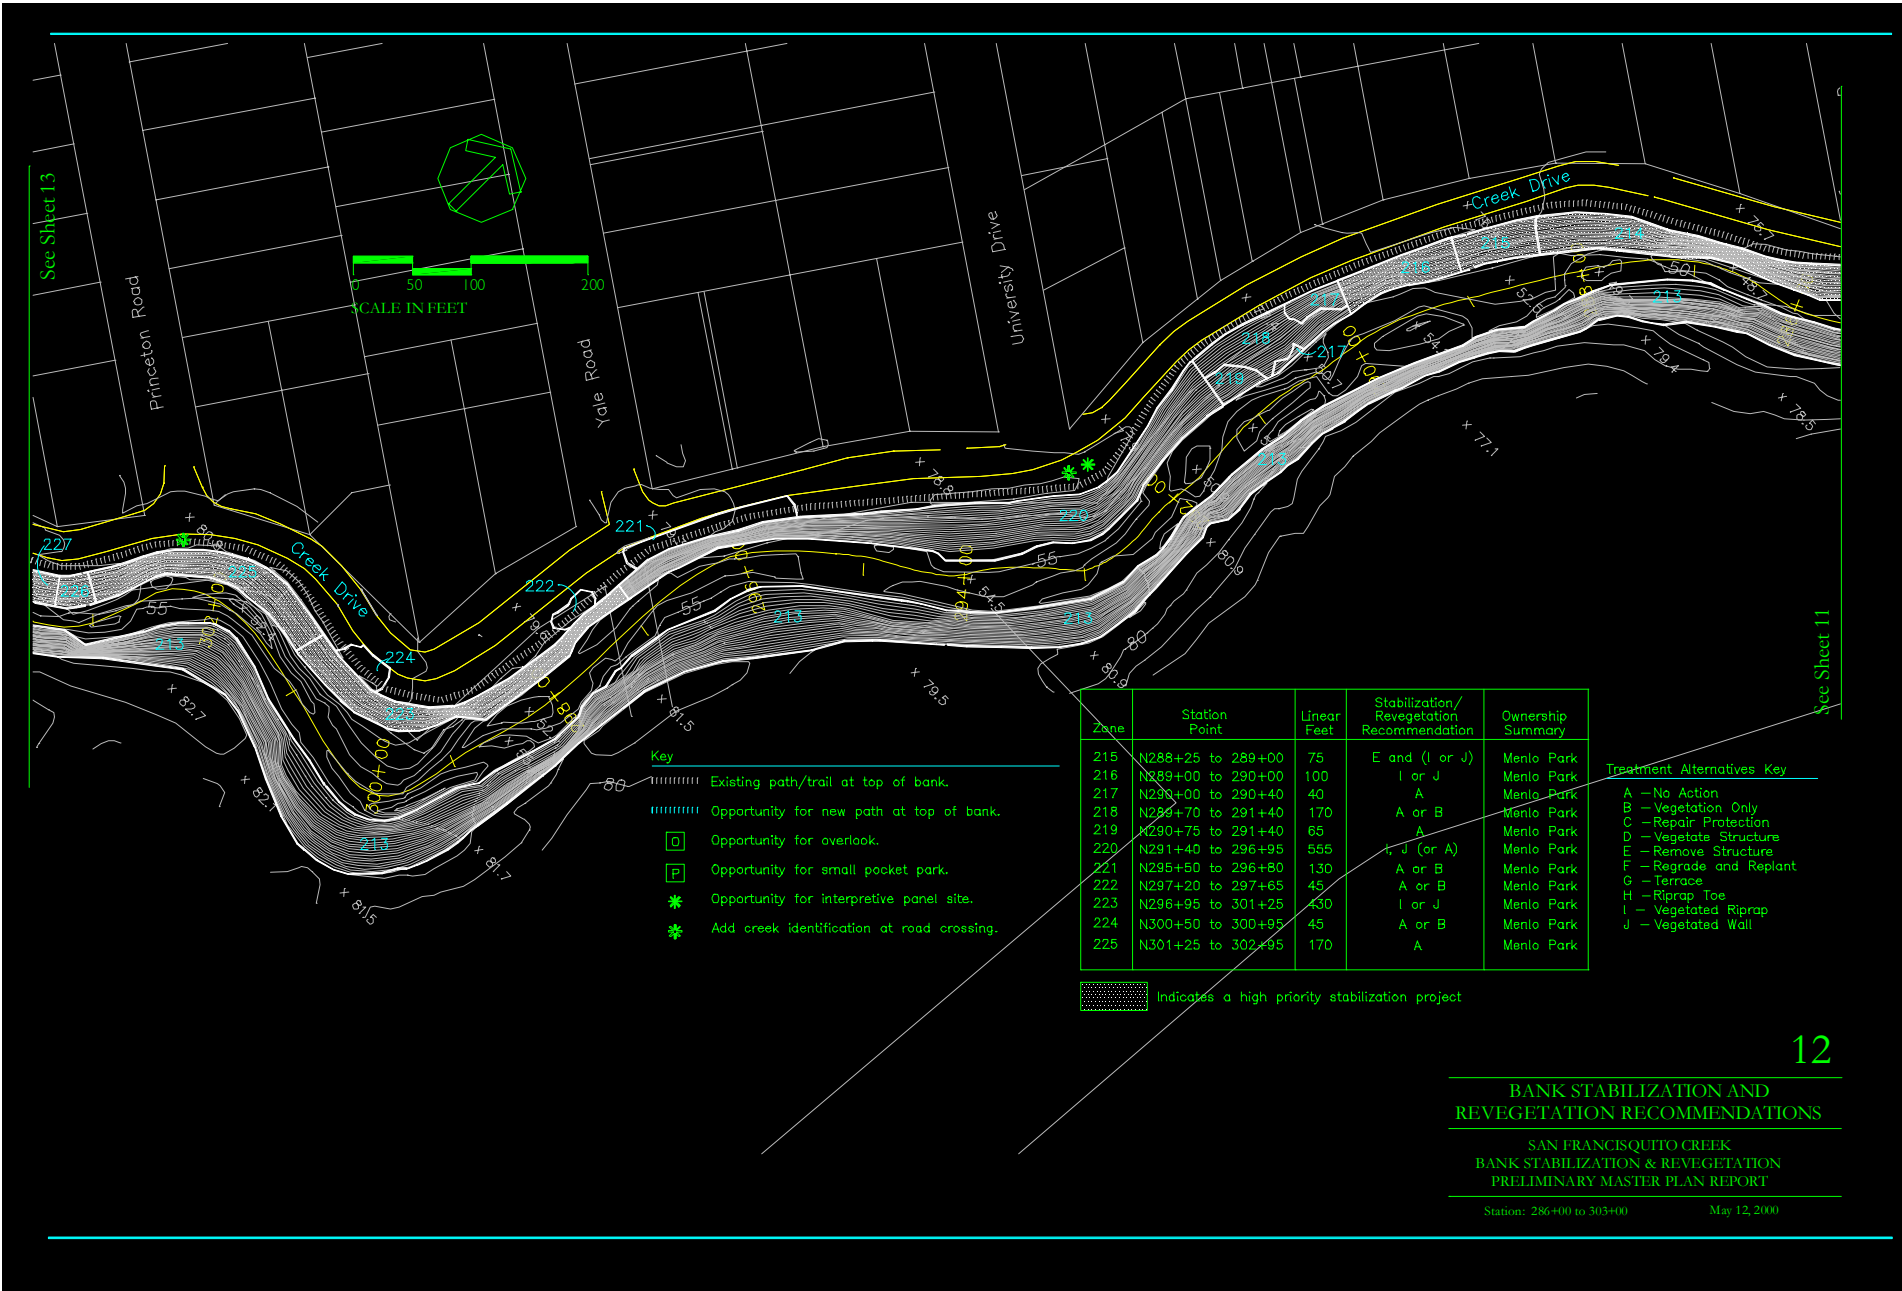
- Key**
- Existing path/trail at top of bank.
 - Opportunity for new path at top of bank.
 - Opportunity for overlook.
 - Opportunity for small pocket park.
 - Opportunity for interpretive panel site.
 - Add creek identification at road crossing.

Zone	Station Point	Linear Feet	Stabilization/Revegetation Recommendation	Ownership Summary
215	N288+25 to 289+00	75	E and (I or J)	Menlo Park
216	N289+00 to 290+00	100	I or J	Menlo Park
217	N290+00 to 290+40	40	A	Menlo Park
218	N290+70 to 291+40	170	A or B	Menlo Park
219	N290+75 to 291+40	65	A	Menlo Park
220	N291+40 to 296+95	555	I, J (or A)	Menlo Park
221	N295+50 to 296+80	130	A or B	Menlo Park
222	N297+20 to 297+65	45	A or B	Menlo Park
223	N296+95 to 301+25	430	I or J	Menlo Park
224	N300+50 to 300+95	45	A or B	Menlo Park
225	N301+25 to 302+95	170	A	Menlo Park

Indicates a high priority stabilization project

- Treatment Alternatives Key**
- A - No Action
 - B - Vegetation Only
 - C - Repair Protection
 - D - Vegetate Structure
 - E - Remove Structure
 - F - Regrade and Replant
 - G - Terrace
 - H - Riprap Toe
 - I - Vegetated Riprap
 - J - Vegetated Wall
